MISSISSIPPI ENVIRONMENTAL GEOLOGY

David T. Dockery III and David E. Thompson

Mississippi Department of Environmental Quality
Office of Geology
Second Edition, 2019

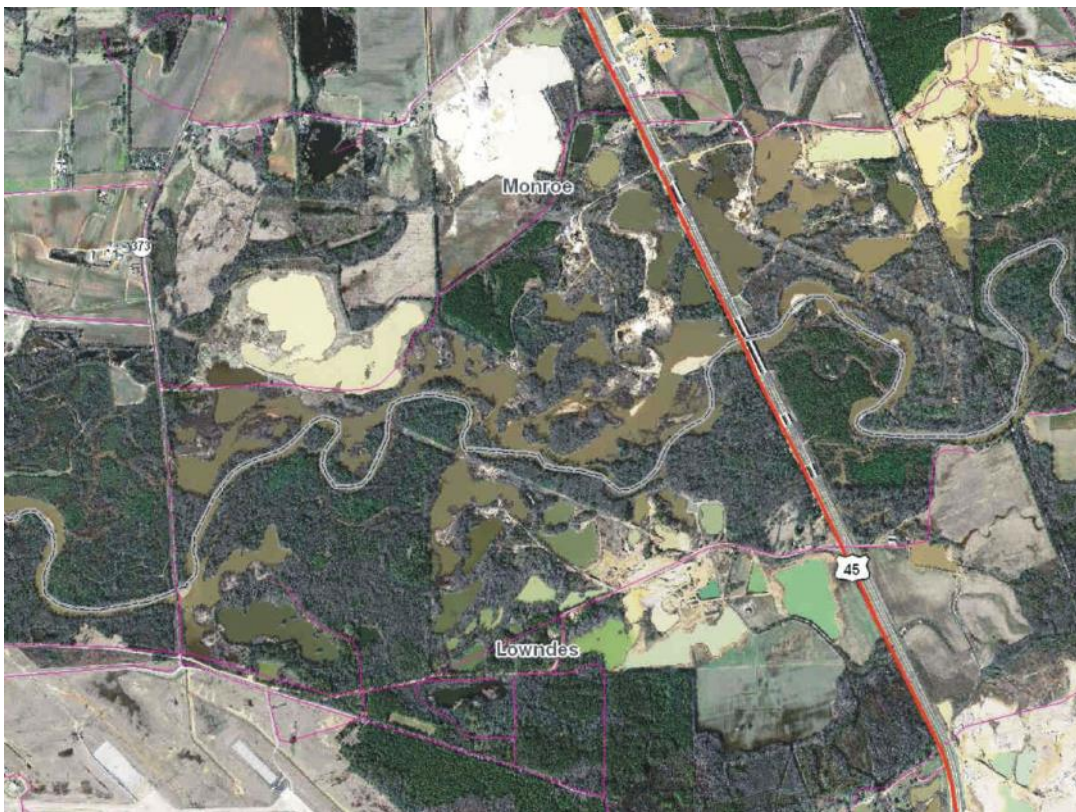
Figure 314. Areal photograph showing flooded gravel pits along the course of the Buttahatchee River along the Monroe-Lowndes County line in Mississippi. Columbus Air Force Base is in the lower left corner of the picture. Image 2039.

Buttahatchee River. The Buttahatchee River is a major tributary of the Tombigbee River in northeastern Mississippi. It supports 37 species of mussels, four of which are federally listed. In the 1970s, the Tennessee-Tombigbee Waterway was constructed, and gravel mines were established near the mouth of the river. Pre- and post-waterway surveys documented a 95% decline in mussel abundance and a 60% decline in mussel diversity in the lower portions of the river. **Figures 311-312** show the Buttahatchee River before and after headcutting upstream from gravel mining operations. **Figures 313-314** show flooded gravel pits along the course of the Buttahatchee River at Hamilton, Mississippi.

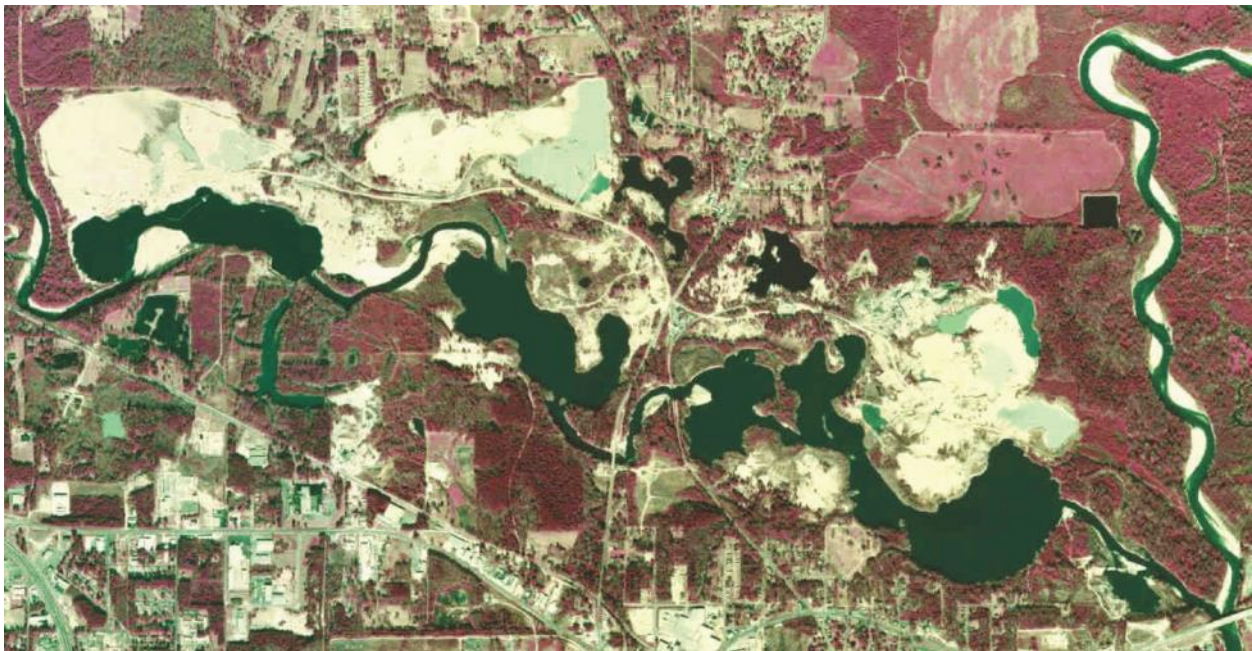
Figure 316. False color aerial photograph of gravel mines in the Bouie River near the confluence with the Leaf River north of Hattiesburg, Mississippi.. Image 2041.

Bouie River. Mossa (2006) quantified the channel planform change in the Bouie River north of Hattiesburg, Mississippi, over the time interval from 1955 (not long after in-stream mining began in the 1940s) to 1996 (just after mining was curtailed by the Mississippi Department of Environmental Quality). **Figures 315-316** show the Bouie River flowing in and out of old gravel pits. Mossa used a series of indices to quantify channel plan-

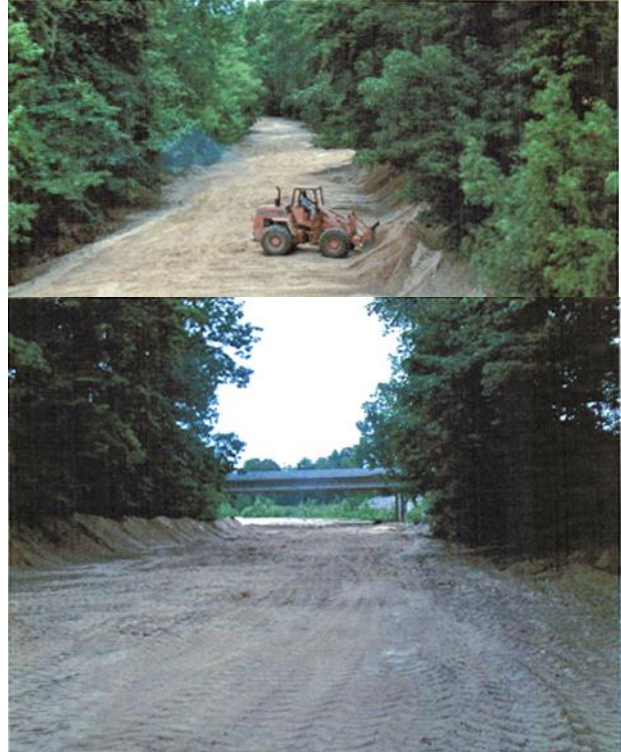
Figure 320. Gravel mining in this stream tributary in west-central Mississippi has leveled the stream bed to a flat road with no riffles, pools, stream channel, water, aquatic life, or watering holes for wildlife. Image 2015 at top and 2016 at bottom.

Healthy rivers, streams, and creeks are composed off shallows and deeps called riffles and pools. At high flow, the stream is full covering both riffles and pools in deep water. At low flow, especially during droughts, the pools maintain reservoirs of water, which keep aquatic animals alive and provides watering holes for other wildlife. Thus a comparison is made between a living person and a living stream. In this analogy, the electrocardiogram (EKG) waveform of a living person shows the rhythm of a heart beat in which the upward R wave is a stream riffle, and the downward S wave is a pool (Figure 319). A flat line with the absence of these waves means death for both a person and the ecology of a stream (figures 320-322).

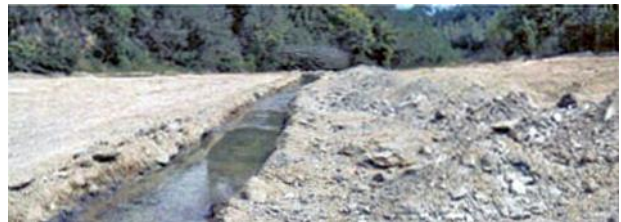
Figure 321. An artificial straight channel cut through a mined-out stream in west-central Mississippi. Image 2012.

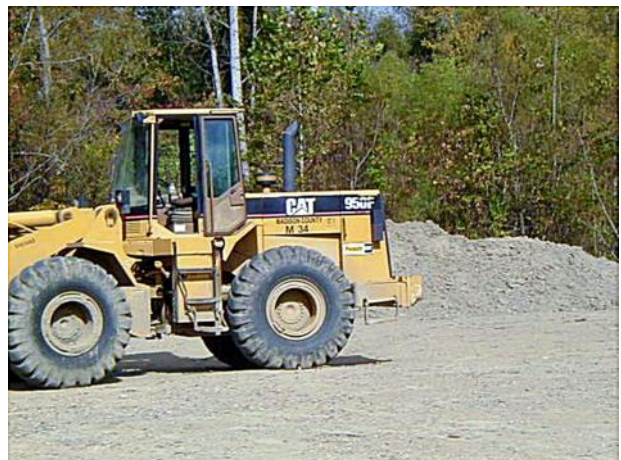
Figure 322. A county front end loader mining gravel from the stream of a neighboring county. Image 2010.

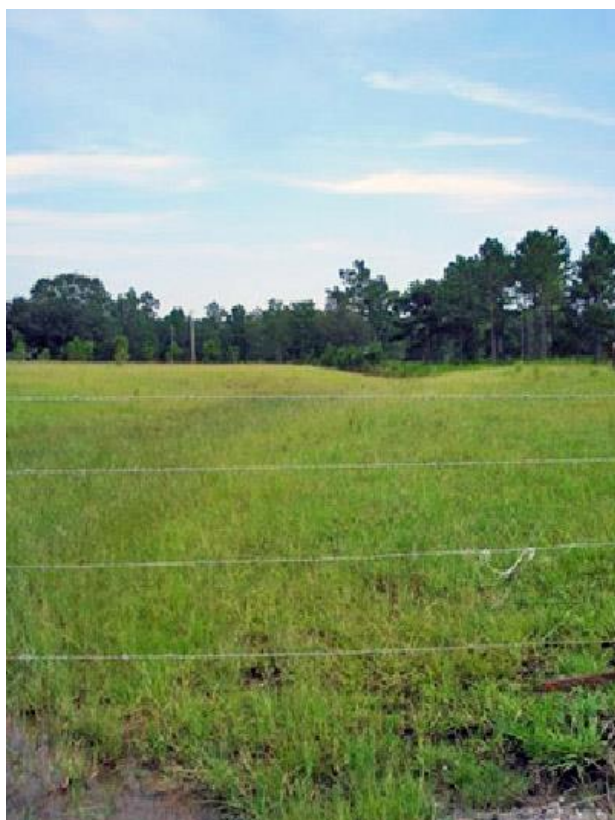
Figure 323. Pasture and hay-land planting was necessary in establishing long-term vegetation in order to reduce sediment contribution from highly erosive areas near Orphan Creek. Picture (digital; Image 2498).

In 2007, MDEQ partnered with the Mississippi Soil and Water Conservation Commission and the U.S. Department of Agriculture's Natural Resources Conservation Service (NRCS) to implement best management practices (BMPs) within the watershed. BMP installation within the Orphan Creek sub-watershed began in early 2008 and was completed later that year. The BMPs included over 190 acres of nutrient management, nearly 40 acres of pasture and hay-land planting (**Figure 323**), and over 2,800 feet of cattle fencing (**Figure**

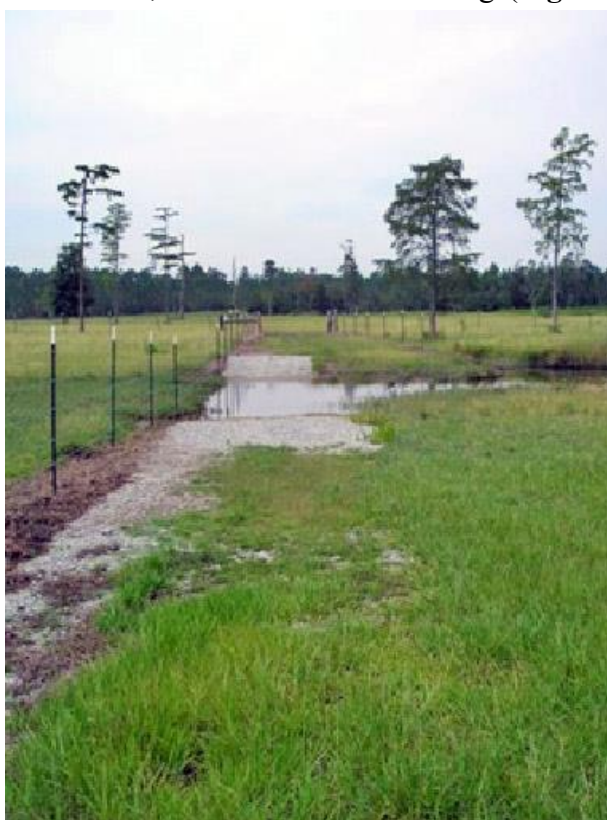
Figure 324. Cattle fencing along Orphan Creek was an integral part of creek restoration in areas of heavy cattle influence. The new fencing will keep cattle from being able to gain access to the creek, alleviating direct nutrient loads within the creek. Picture (digital; Image 2499).

324) within the Orphan Creek sub-watershed. After addressing the causes of pollution and demonstrating in-stream improvements within Orphan Creek, BMP installation continued through 2011, comprising a total of 43 BMPs covering 533 acres within the much broader Dead Tiger/Orphan Creek Watershed (**Figure 325**).

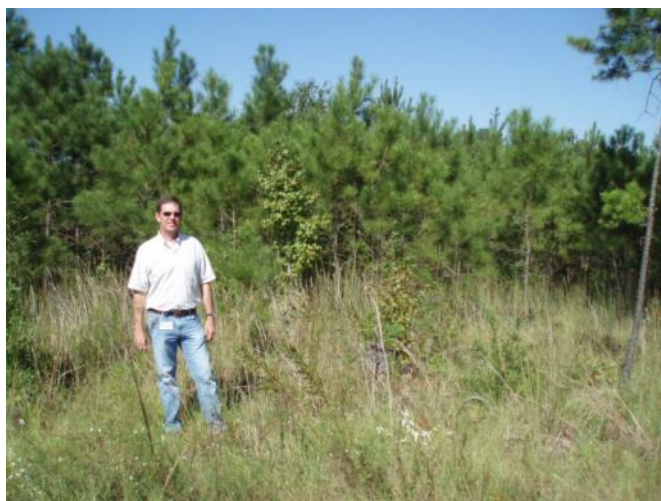
Figure 327. Ken McCarley standing on the edge of the reclaimed first permitted mine in Mississippi, October 3, 2008. The volunteer pines have grown since the revegetation timber was harvested. Picture (digital; Image 2045) was taken on October 3, 2008.

Recently MDEQ Office of Geology staff visited the site of this first permit. Ken McCarley and Michael Bograd were shown the site (Figure 327) by Andy Donahoe of Green Brothers Gravel Company. The reclamation remains successful, thirty years after the successful launch of Mississippi's surface mining regulation.

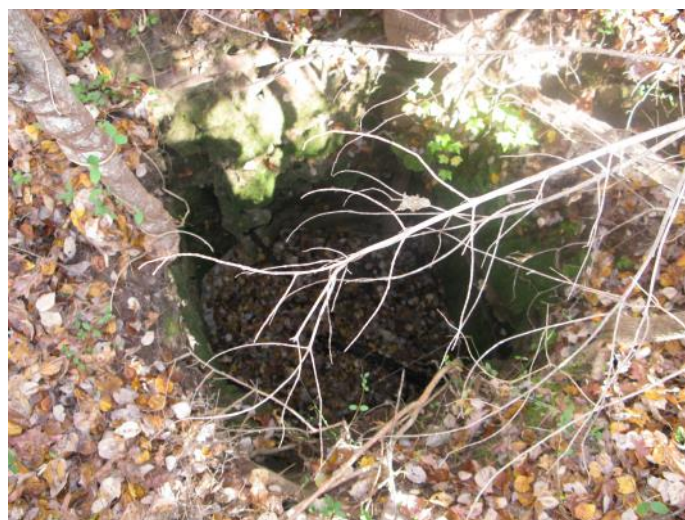
Figure 328. A 6' x 8' x 11' deep dry, vertical air shaft at Russell, Lauderdale County. Picture (digital; Image 2046) was taken on October 15, 2008.

Vertical air shafts into former underground coal mines have been found east of Meridian at Russell and near Ackerman.

It is DEQ's intent, given landowner permission, to reclaim these sites to eliminate hazardous situations (**figures 328-330**). The air shafts are 11 and 23 feet deep with vertical walls. Anyone accidentally falling into one of them would be trapped if they were alone. The remainder of the roof of the mine near Louisville could collapse at any time and crush or trap anyone in it. Fishing in the shallow surface mine near Reform is not planned to be disturbed.

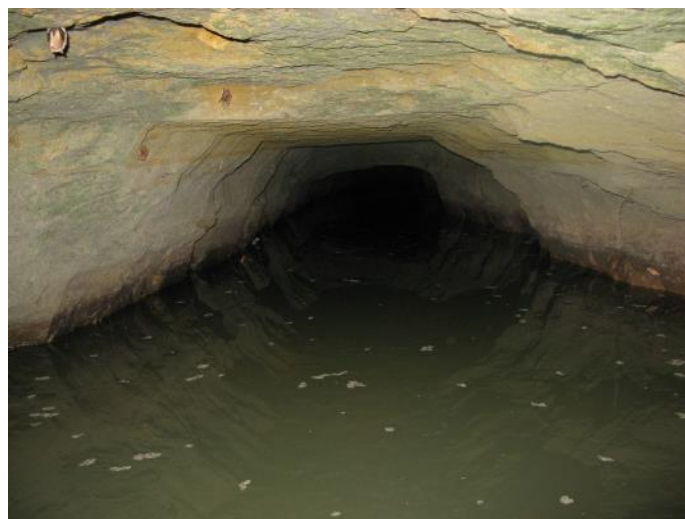
Figure 329. Partially flooded underground mine near Louisville, Winston County. Picture (digital; Image 2047) was taken on October 15, 2008.

Louisville. No air shaft has been found, but the entrance to the mine is still open. A part of the mine "roof" at the entrance has collapsed, creating a dam which has trapped rain and ground water, flooding the floor of the mine. The size of these mines is unknown, but all are believed to be small by modern standards, likely less than 1-2 acres. However, at least one was large enough to have been described as using "room and pillar mining," a common method still used today. One small surface coal mine is well known locally at Reform. Covering about a half acre, it is still used today as a fishing pond.

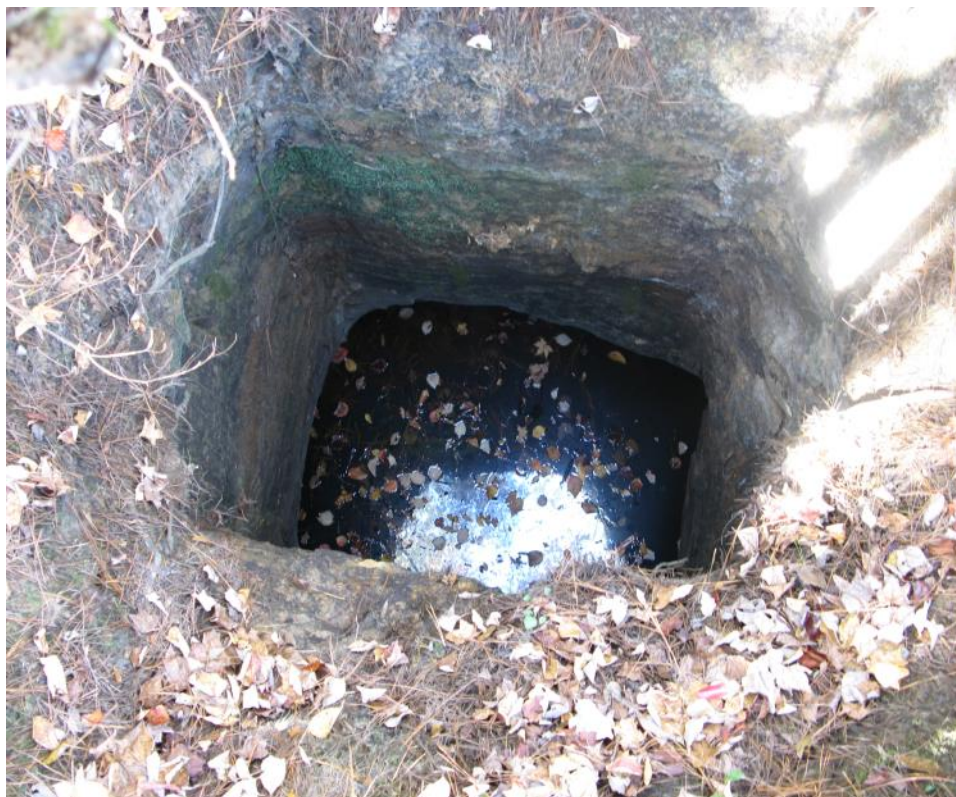
Figure 330. A 10' x 11' x 23' deep flooded vertical air shaft near Ackerman, Choctaw County. Picture (digital; Image 2048) was taken on October 15, 2008.

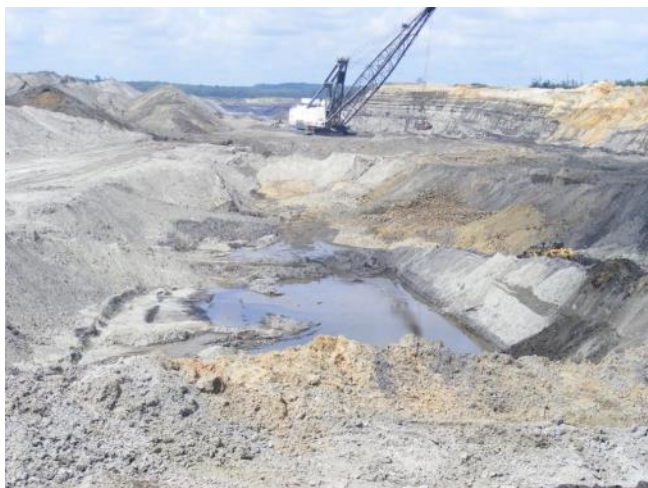
Figure 332. The length of the lignite mine pit currently opened. Picture (digital; Image xxxx) was taken in 2009. Picture (digital; Image 2050) was taken on August 10, 2009.

Figures 331-333 show the members of the committee who went, the drag line, the length of the pit currently opened, and a picture of an area in the foreground that has been reclaimed, in the middle a part being filled in, and the background is the open pit. What is awesome is the dragline is so large, most of us thought it was one quarter to a half mile away from where we stood---it was over a mile and the pit was two miles long. The dragline is electric and (are you ready for this?) powered by AN EXTENSION cord connected to a dedicated substation which buys power from the plant the mine feeds.

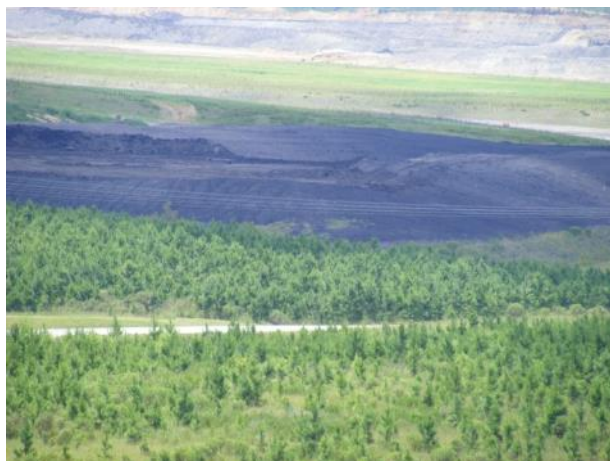
Figure 333. Reclaimed land planted in grass and pine trees in the foreground, lignite stock pile in middle, and the pit in the background. Picture (digital; Image 2051) was taken on August 10, 2009.

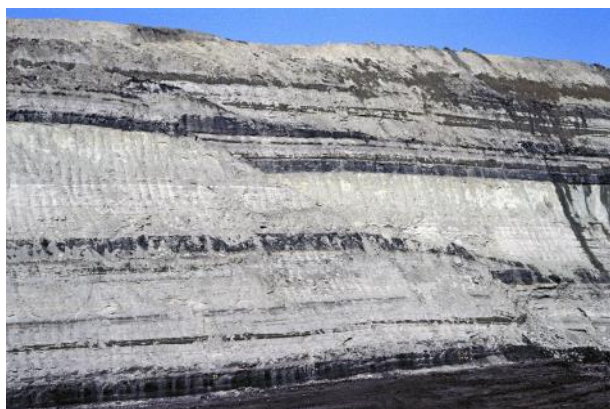
Figure 334. Fault cutting lignite seams at the Red Hills Lignite Mine. Near the top at left, the F seam is against the down-faulted G seam on the right side of the fault. Picture (slide 391-1; Image 20) was taken on November 10, 2004.

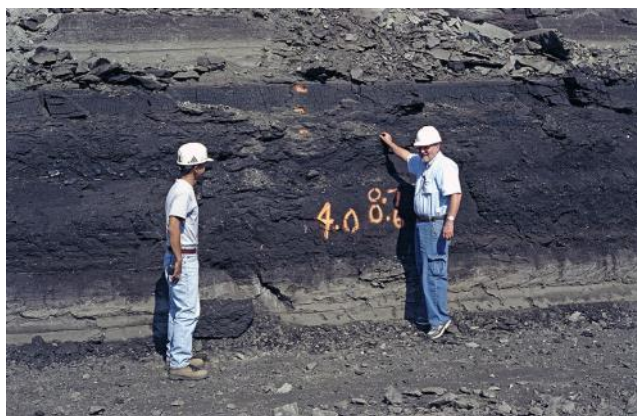
Figure 335. Benson Chow (left) and Ken Davis (right) at the 4.0-foot-thick D seam in the Grampian Hills Member of the Nanafalia Formation in the Red Hills Lignite Mine. Picture (color negative 529-20A; Image 338) was taken on September 29, 2004.

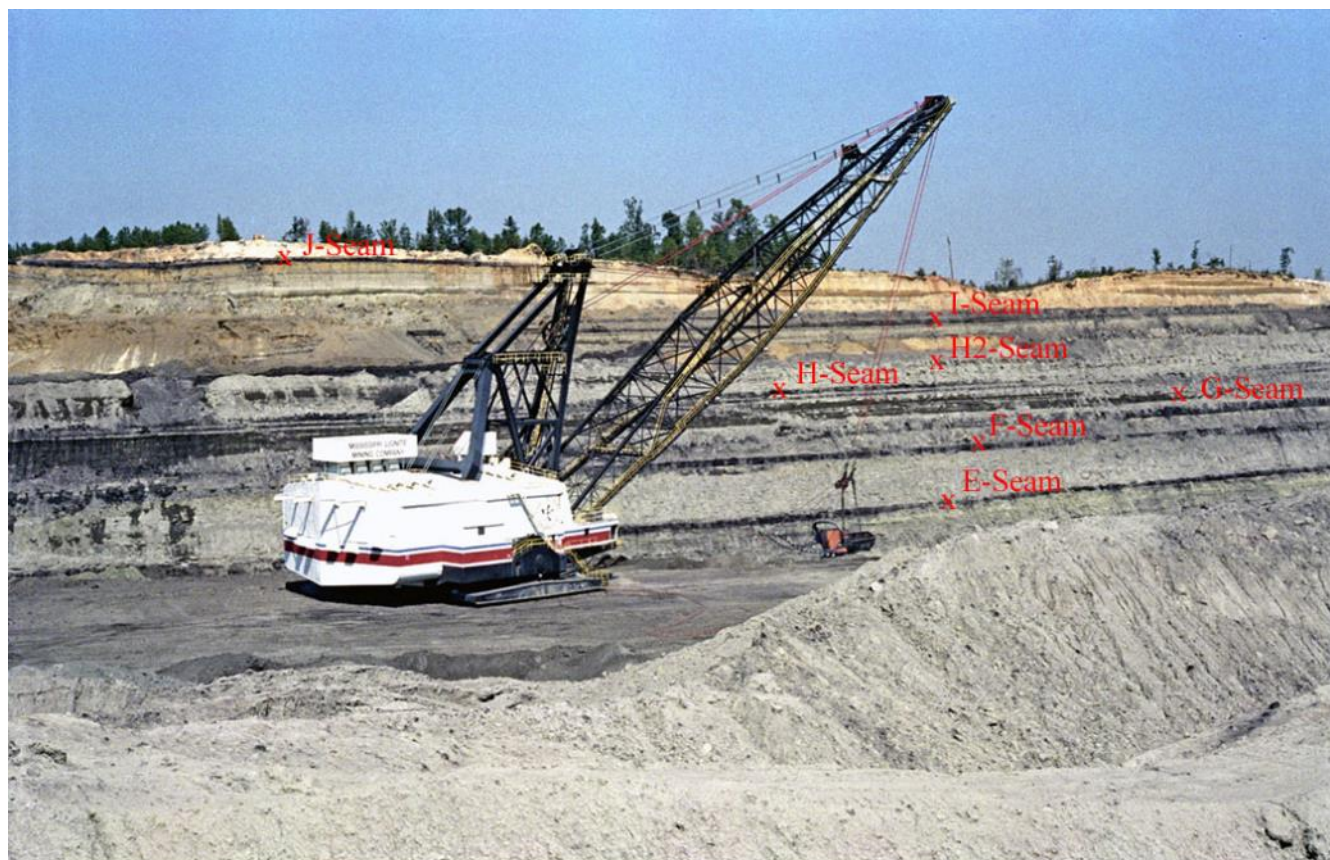
Figure 337. Distant view of lignite seams in the Grampian Hills Member and the lower Tuscaloosa Formation. The J-seam is the top lignite seam at left where it overlies lower Tuscaloosa channel sands. The I-seam is the highest lignite seam at right, but this seam is absent at left where channel sands have cut down to the H seam. Seams were labeled by Benson Chow. Picture (color negative 530-28A; Image 84B) was taken on September 29, 2004.

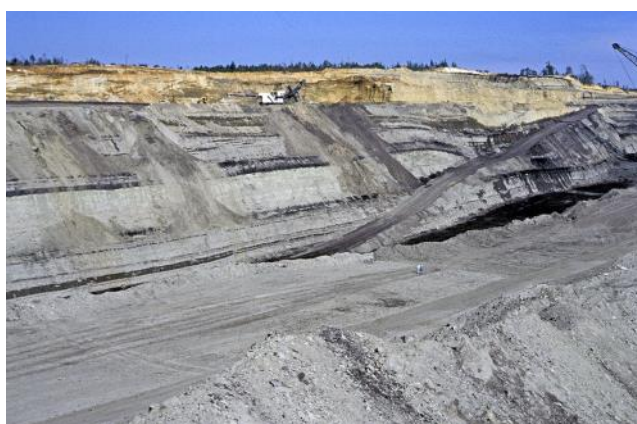
Figure 338. A channel sand in the lower Tuscaloosa Formation at the Red Hills Lignite Mine underlies the J seam and, at right, cuts out the I and H2 seams. The G and F seams of the Grampian Hills Member can be seen bending beneath the channel sand where they intersect the ramp ascending from the quarry floor. Picture (slide 393-38; Image 23) was taken on November 10, 2004.

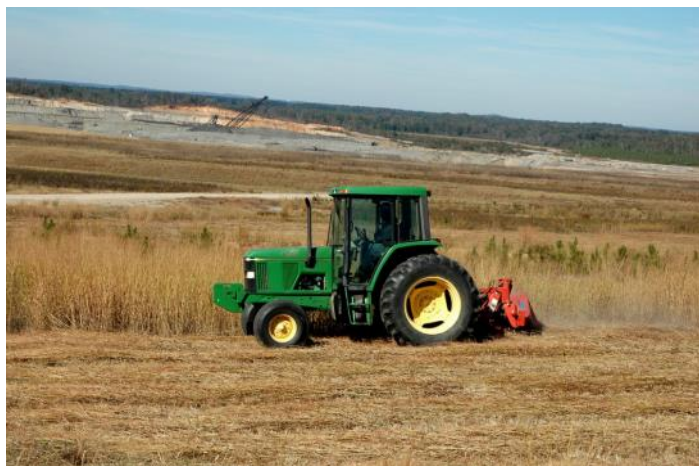
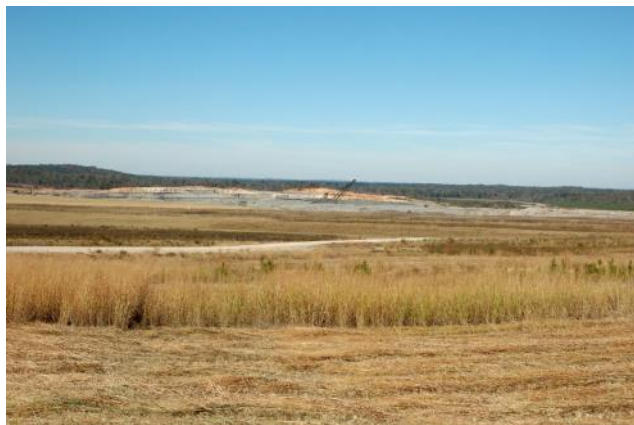
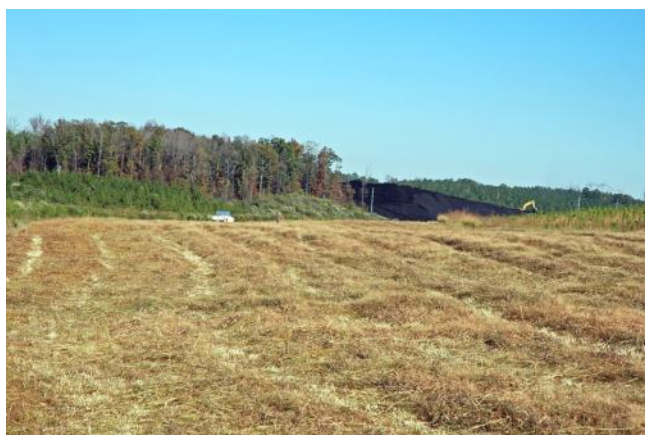
Figure 342. Tractor mowing hay from the switchgrass planted on reclaimed land at the Red Hills Lignite Mine. Picture (digital; Image 2068) was taken by David Lang in November of 2010.

Figure 341. Reclaimed land from the Red Hills Lignite Mine planted in switchgrass where the mine was in 2004/2005. The active mine can be seen in the distance. Picture (digital; Image 2067) was taken by David Lang in November of 2010.

Figure 343. Moved hay from switchgrass planted on reclaimed land at the Red Hills Lignite Mine where the mine was in 2004/2005. Trees in the distance mark the boundary of the original mine cut. Pine trees on the intervening slope are part of an earlier reclamation. Picture (digital; Image 2069) was taken by David Lang in November of 2010.

millet and Bermuda grass to provide soil stabilization followed by loblolly pines, or alternatively wheat is planted in the cool season to stabilize reclaimed new soil. Initial growth of the loblolly pines is 0.37 to 0.91 meters per year with a survival rate of 70% to 90% after three years. Native grasses reinvaded the reclaimed area from seeds present in the topsoil substitute or wind dispersal as the Bermuda grass declined.

Switchgrass was planted into killed Bermuda grass at the Red Hills Lignite Mine following disking in August of 2008 and replanted on May of 2009 (Lang et al., 2011).

Once established, switchgrass is an excellent soil stabilizer, but it takes a year to provide adequate ground cover and two years to reach its full potential (**figures 341-343**).

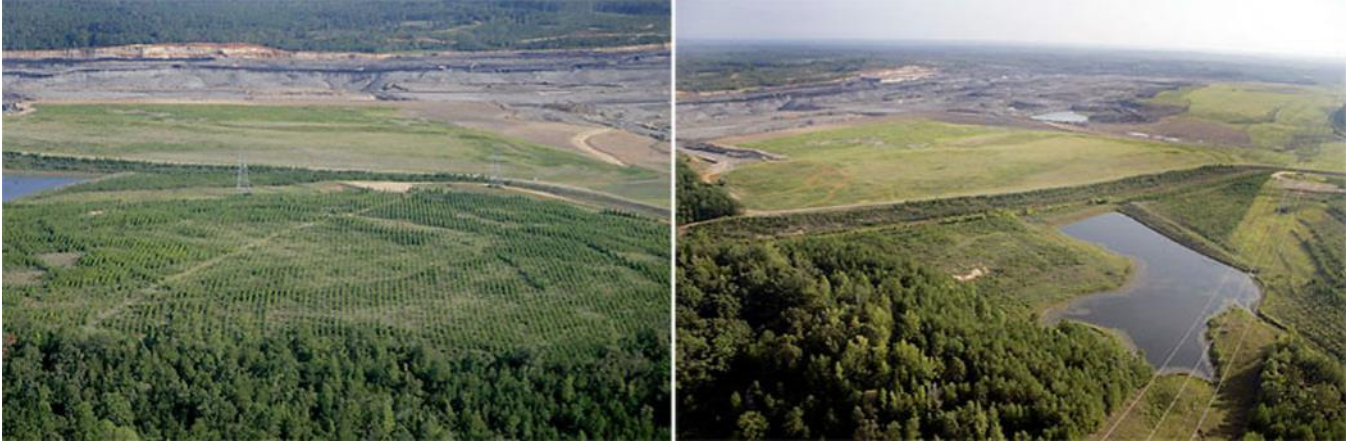
Figure 344. Left: Pine trees planted on reclaimed land at the Red Hills Lignite Mine. The lake at the far left is Pond RP-33-1. Right: Pond R-1 behind a raised area of land that hold the soil from the mine's original box cut. Pictures (digital; Image 2070) from the Mississippi Development Authority website (2011).

Reclaimed and modified lands at the Red Hill Lignite Mine also include lakes as shown in **Figure 344**. The two ponds labeled RP are reclamation ponds. Ponds in the mine area are shown in **figures 345-349** and are located on the areal photograph in **Figure 350**.

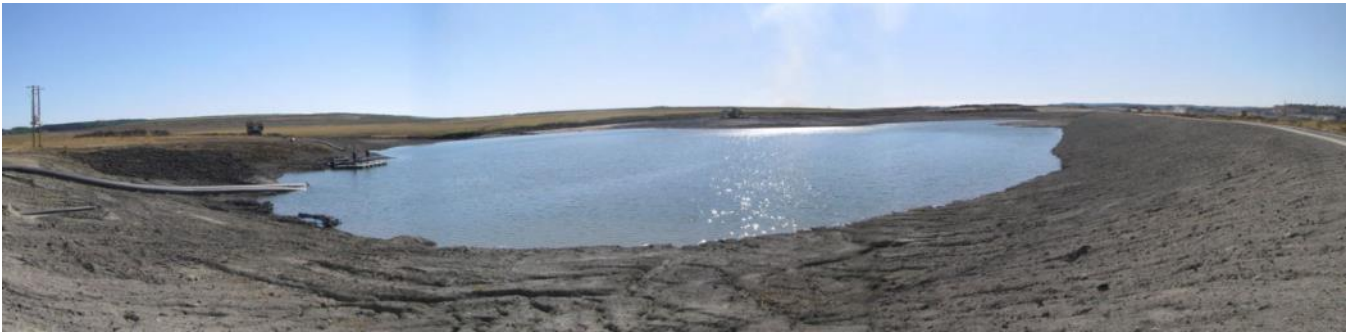
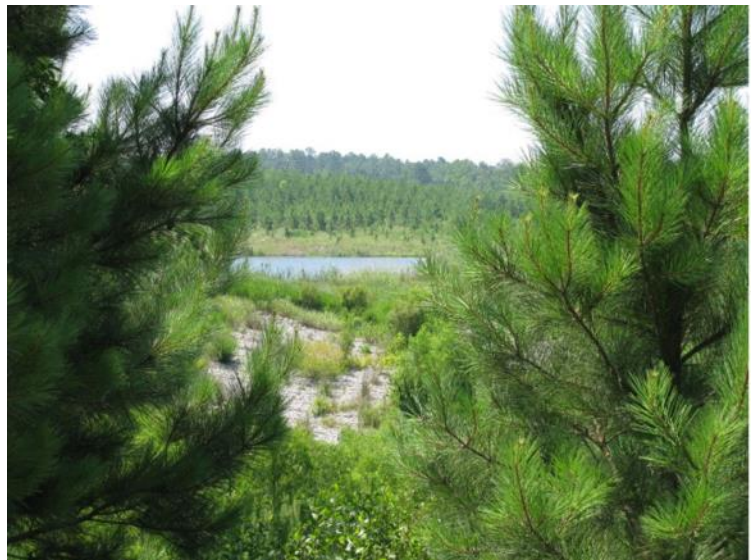
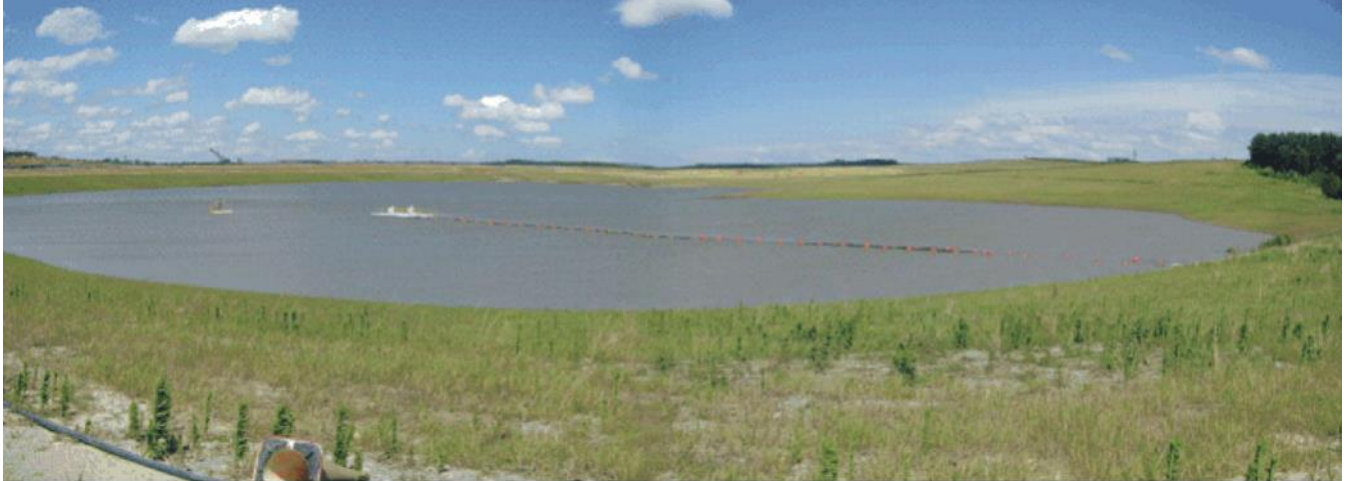
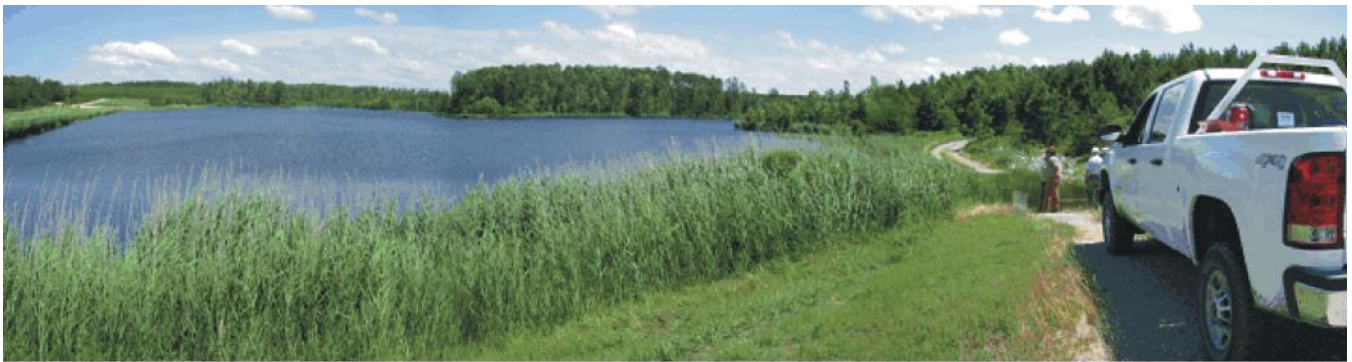
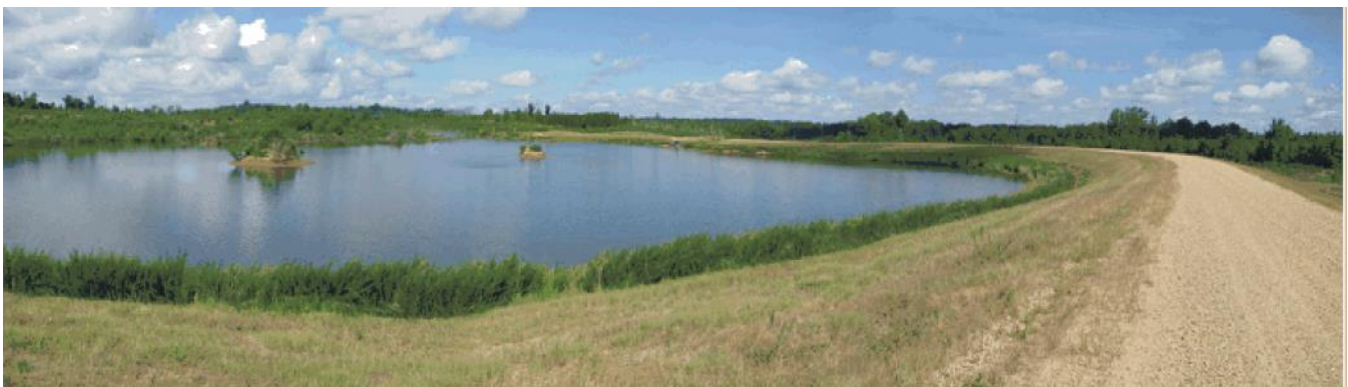
Figure 345. Panoramic view of the construction of Pond RP-27-2 on reclaimed land at the Red Hills Lignite Mine. Picture (digital; Image 2071) was taken by Ron Porter on September 15, 2011.

Figure 346. View of Pond P-4-1 through pine trees planted on reclaimed land at the Red Hills Lignite Mine. Picture (digital; Image 2072) was taken by Ron Porter on September 15, 2011

Figure 347. Panoramic view of Pond RP-33-1 on land reclaimed at the Red Hills Lignite Mine. Picture (digital; Image 2073) was taken by Ron Porter on September 15, 2011.

Figure 348. Panoramic view of Pond P-1 at the Red Hills Lignite Mine. Picture (digital; Image 2074) was taken by Ron Porter on September 15, 2011.

Figure 349. Panoramic view of Pond SP-4 at the Red Hills Lignite Mine. Picture (digital; Image 2075) was taken by Ron Porter on September 15, 2011.

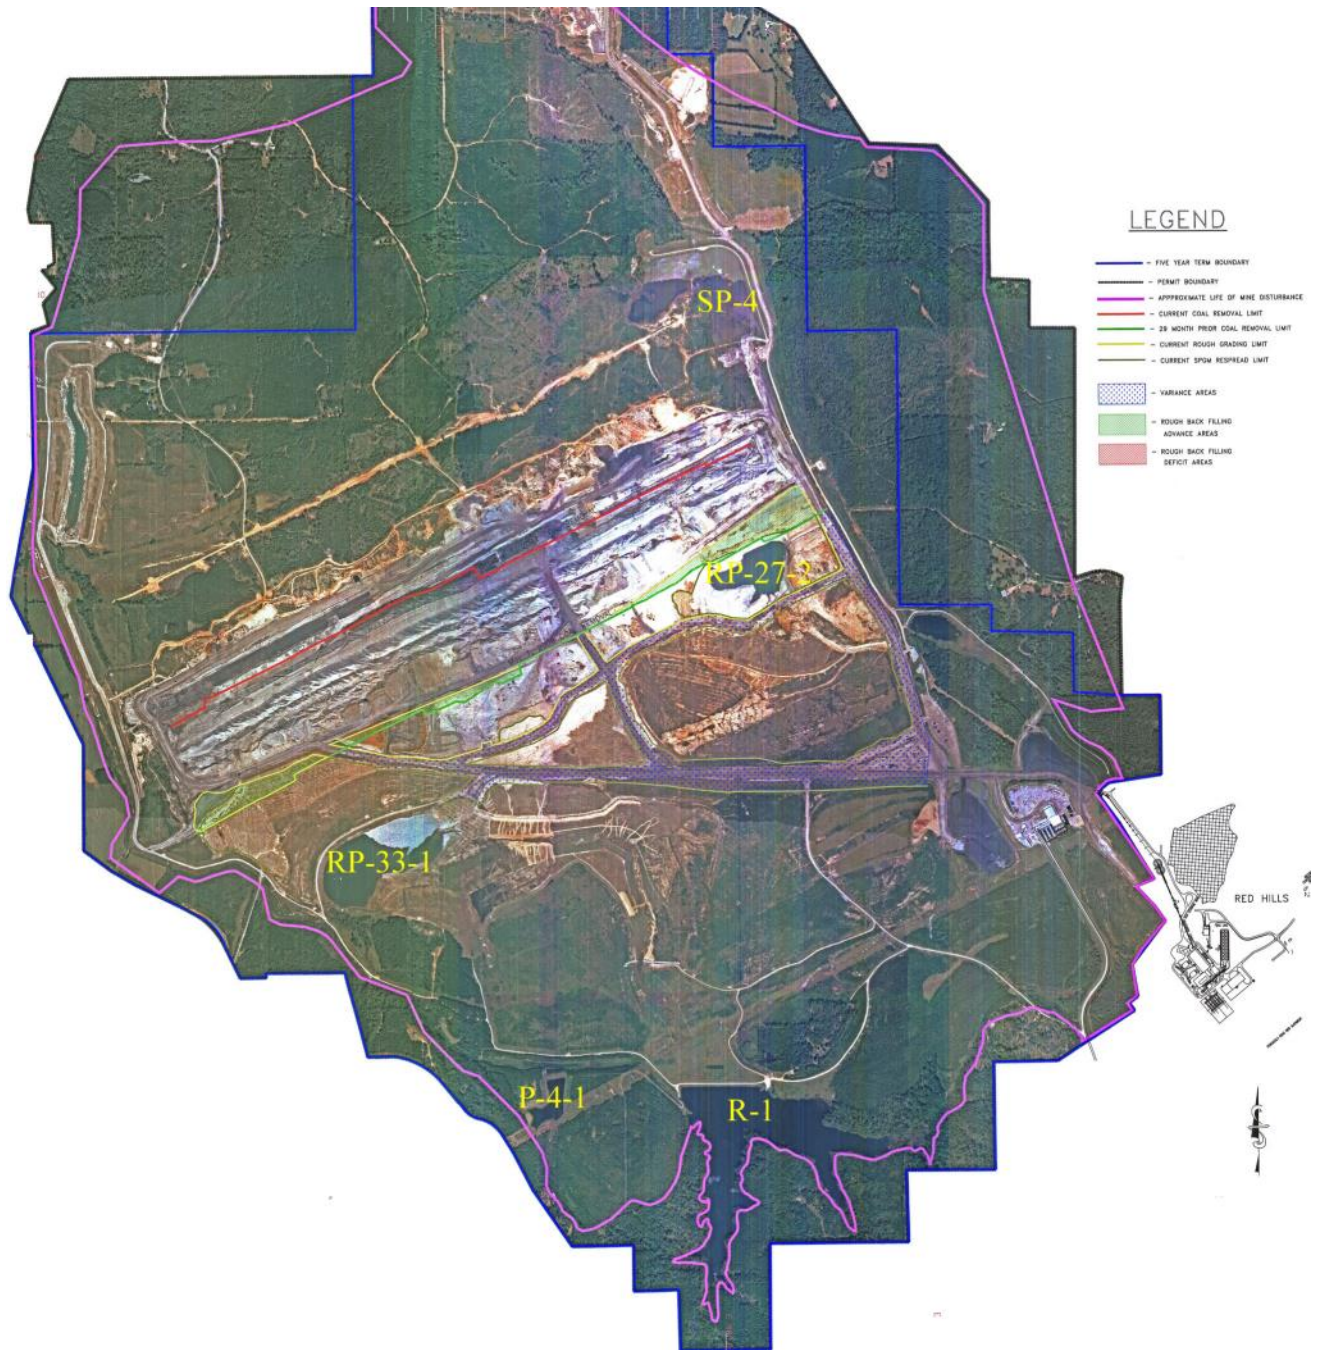
Figure 350. Status of land reclamation at the Red Hills Lignite Mine as of October 2011. The blue line is the five year term boundary. The black border line is the permit boundary. The magenta line is the approximate life of the mine disturbance. The red line is the current coal removal limit. The green line is the 29 month prior coal removal limit. The yellow line is the current rough grading limit, and the narrow dark green line is the SPGM respread limit. Ponds are labeled in yellow. Image 2076.

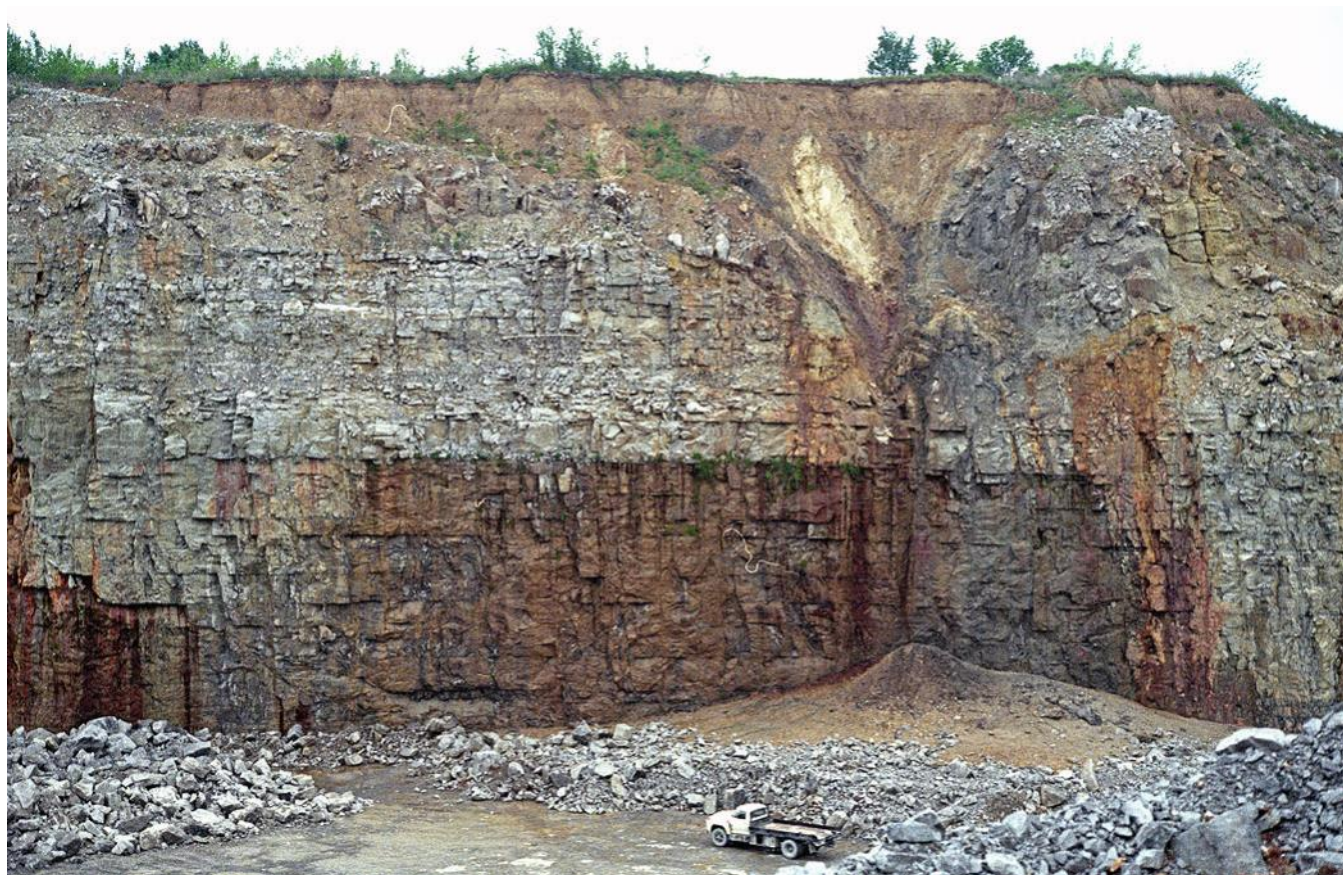
Figure 351. Paleo-sinkhole in the Tusculmbia Limestone at the Vulcan Materials Company's Iuka quarry in Tishomingo County. Sediment filling the sink hole has spilled over the quarry wall, making a pile to the upper right of the truck on the quarry floor. Picture (color negative 419-8; Image 382) was taken on May 8, 1989.

The Iuka quarry was excavated as a rectangular box cut in the flood plain of Cripple Dear Creek about a mile west of the Alabama state line, and the quarry floor extended some 150 feet below the level of the flood plain. The creek was diverted around the quarry, and spring water from the Tusculmbia Limestone in the high walls was pumped from the lower quarry to the surface. When the quarry was abandoned, it was flooded by the waters of Cripple Dear Creek, thus making it the state's deepest lake. **Figures 351-352** show the height of the quarry's high wall and give evidence of the depth of the lake that now occupies the quarry.

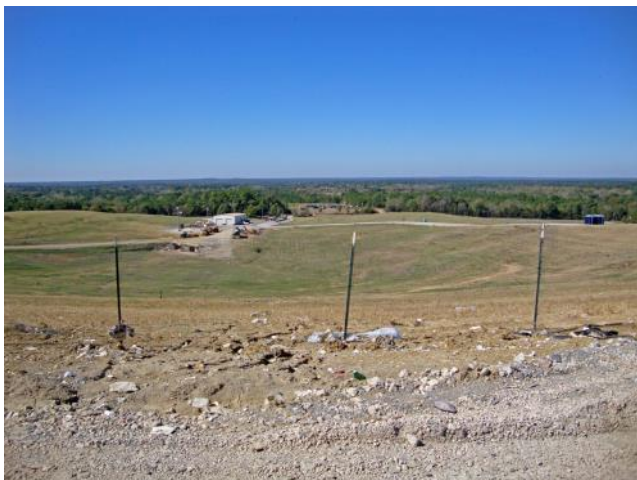
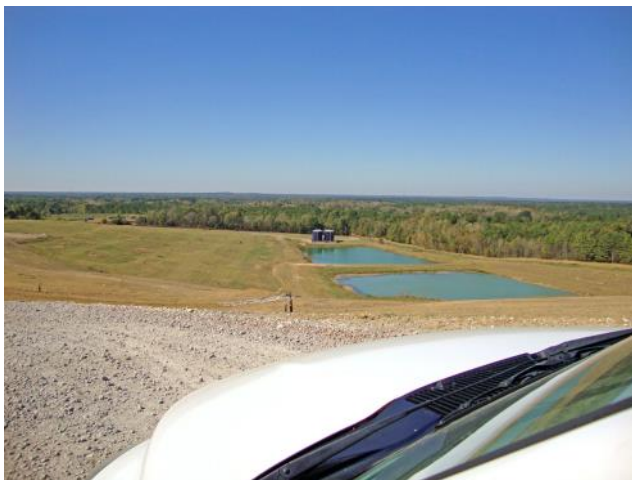
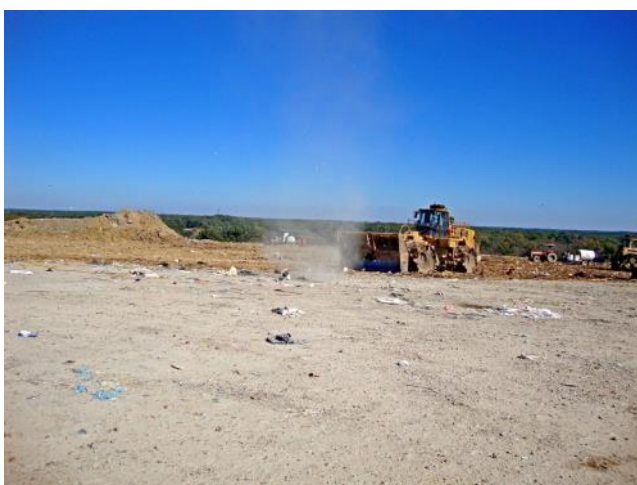
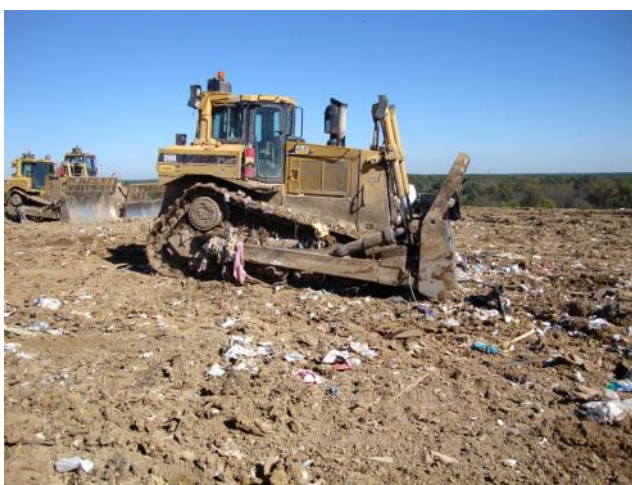
Figure 357. Little Dixie Landfill weighing station (left) and leachate storage (right). Picture (digital; Image 2081) was taken on October 30, 2011.

Figure 358. Leachate storage and treatment ponds at the Little Dixie Landfill. Picture (digital; Image 2082) was taken on October 30, 2011.

Figure 359. Little Dixie Landfill whirlwind illustrates the dust potential from strong winds. Picture (digital; Image 2083) was taken on October 30, 2011.

Figure 360. Covering garbage at the Little Dixie Landfill. Picture (digital; Image 2084) was taken on October 30, 2011.

Figures 355-356 show landfill designs for Municipal Waster Landfills such as the following three examples in Mississippi: (1) Little Dixie Landfill (**figures 357-361**), (2) Clearview Landfill (**figures 362-364**), and (3) Prairie Bluff Landfill (**figures 340-342**). Besides the state's 19 Municipal Waste Landfills, the state has 6 Non-Municipal Solid Waste Landfills.

The Little Dixie Landfill in southern Madison County services the Jackson metro area in Hinds, Madison, and Rankin counties, and receives (in 2010) solid waste from some 30 other counties, including Prentiss County in northeastern Mississippi. The landfill is underlain by a 400-foot thick section of Yazoo Clay. Elevations at the landfill provide spectacular vistas of the surrounding terrain, including a view of downtown Jackson (**Figure 346**).

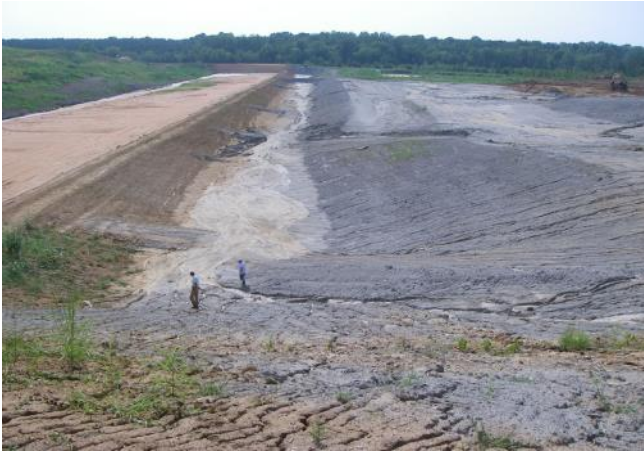
Figure 365. Containment levee (at left) for the Prairie Bluff Landfill (far left) in Chickasaw County. At right is the gray chalky marl of the Prairie Bluff Formation for which the landfill was named. This landfill receive solid waste from 35 counties in 2010. Picture (digital; Image 1052) was taken on August 23, 2007.

The Prairie Bluff Landfill in Chickasaw County serves northern Mississippi and received solid waste from 38 counties in 2010. The landfill is contained within a 70-foot-thick section of chalky marls in the Prairie Bluff Formation. **Figure 365** shows the gray marls of the Prairie Bluff Formation outside the containment wall for the landfill. **Figures 366 and 3** show the landfill's ten thousand gallon leach-

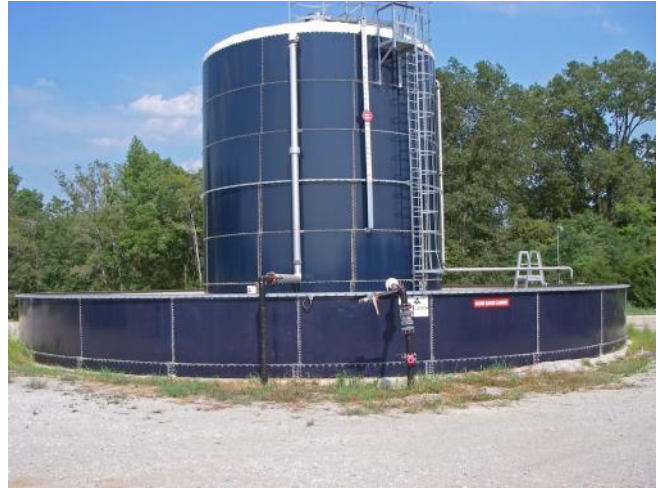
Figure 366. Ten thousand gallon leachate holding tank at the Prairie Bluff Landfill. Picture (digital; Image 2089) was taken on August 23, 2007.

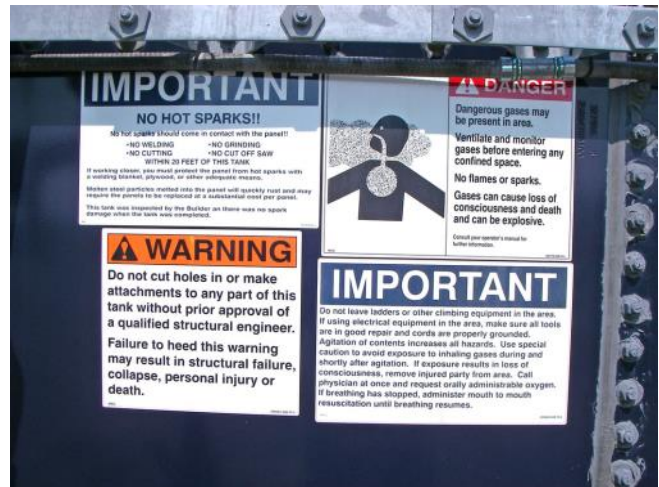
Figure 367. Warning label on the Prairie Bluff Landfill leachate holding tank. The warning is placed because leachate can produce a dangerous/deadly concentration of methane gas. Picture (digital; Image 2090) was taken on August 23, 2007.

ate holding tank. **Figure 367** shows the label on the holding tank, warning of possible dangerous levels of methane.

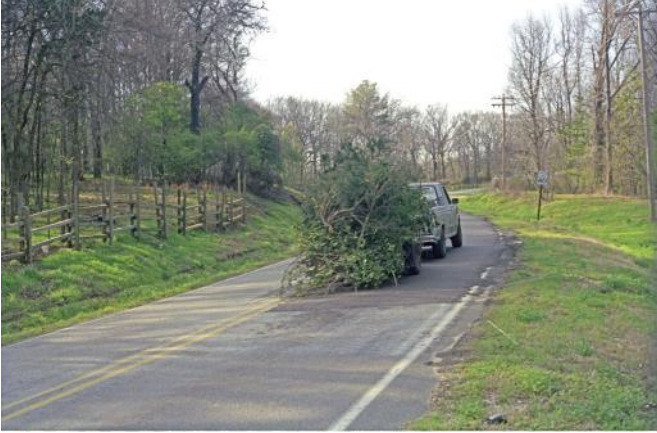
Figure 368. Poorly secured load of natural vegetation headed up a winding road to the dump. Such loads drop debris and cause traffic hazards. Picture (color negative 436-13; Image 2096) was taken on March 18, 1998.

1. Heavy commercial traffic on local roads, including eighteen-wheelers with waste.
2. Falling debris from trucks and trailers. Haulers should cover their loads, but sometimes do not (**figures 368-371**).
3. Frequent flat tires from roofing tacks, nails, screws, and other sharp objects.
4. Destruction of local road surfaces from heavy truck traffic.
5. Liquid waste draining from poorly maintained truck beds.
6. Unauthorized offsite and nearby dumping from those who miss the closing hour or find that the facility will not accept their refrigerator or air conditioner.

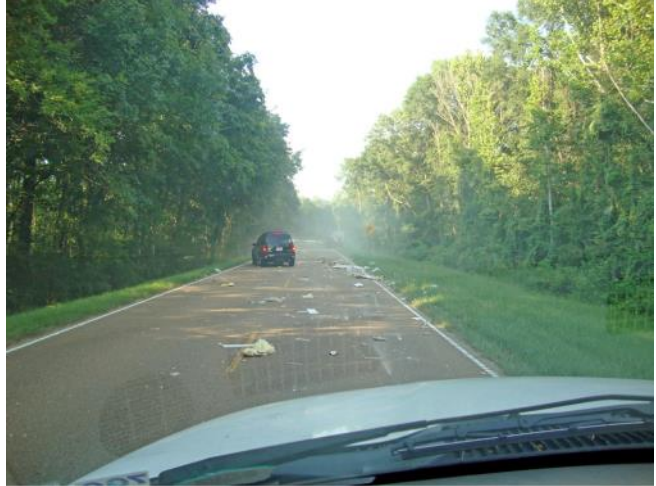
Figure 369. Minivan dodges newly fallen debris from the dump truck ahead, then swerves back into its lane to miss an oncoming pickup truck. Picture (digital; Image 2100) was taken on Pinehaven Road in Clinton, Mississippi, on August 3, 2011.

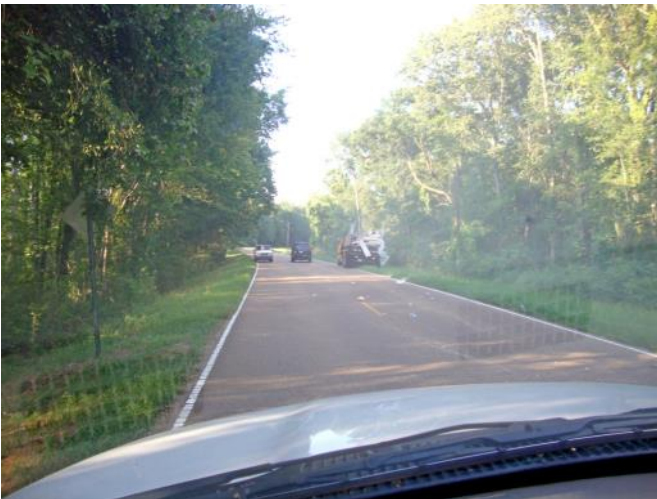
Figure 370. Collision avoided as minivan passes between debris-laden dump truck and oncoming pickup truck on Pinehaven Road in Clinton, Mississippi. Picture (digital; Image 2101) was taken on August 3, 2011.
